# Water Main Break Rates In the USA and Canada: A Comprehensive Study

March 2018

An Asset Management Planning Tool for Water Utilities

Utah State University  
Buried Structures Laboratory  
Steven Folkman, Ph.D., P.E.

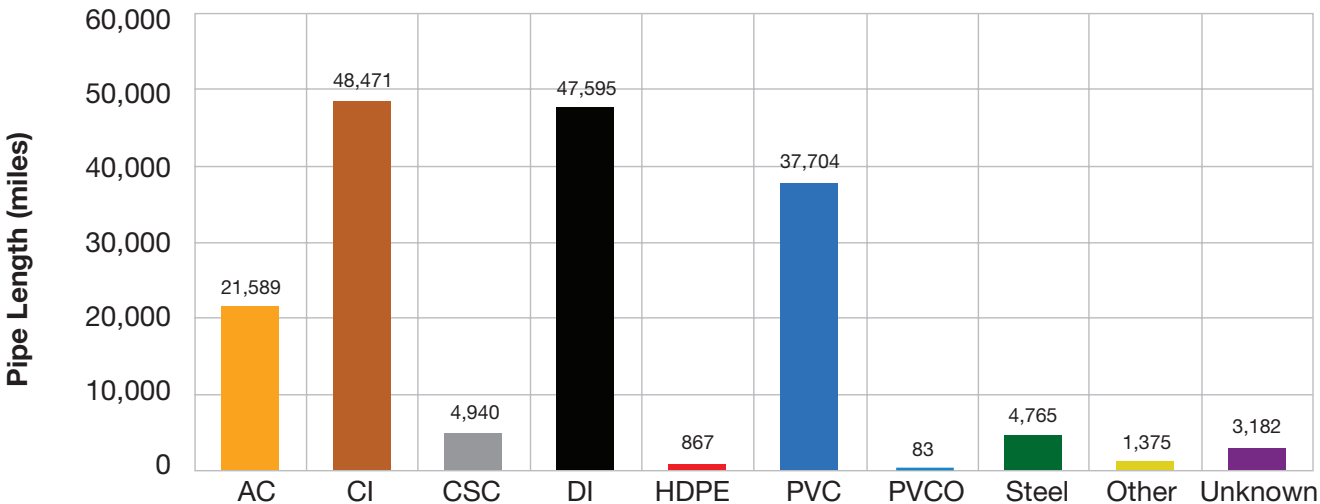
FIGURE 9: LENGTH OF PIPE SEPARATED BY MATERIAL TYPE FROM THE BASIC SURVEY

small amounts of a pipe material utilized, break rates can be highly inaccurate because of large scatter in the data. It is significant to consider that over 91% of the water mains are made from asbestos cement, cast iron, ductile iron, and PVC materials. This is consistent with earlier studies (Stone et al., 2002).

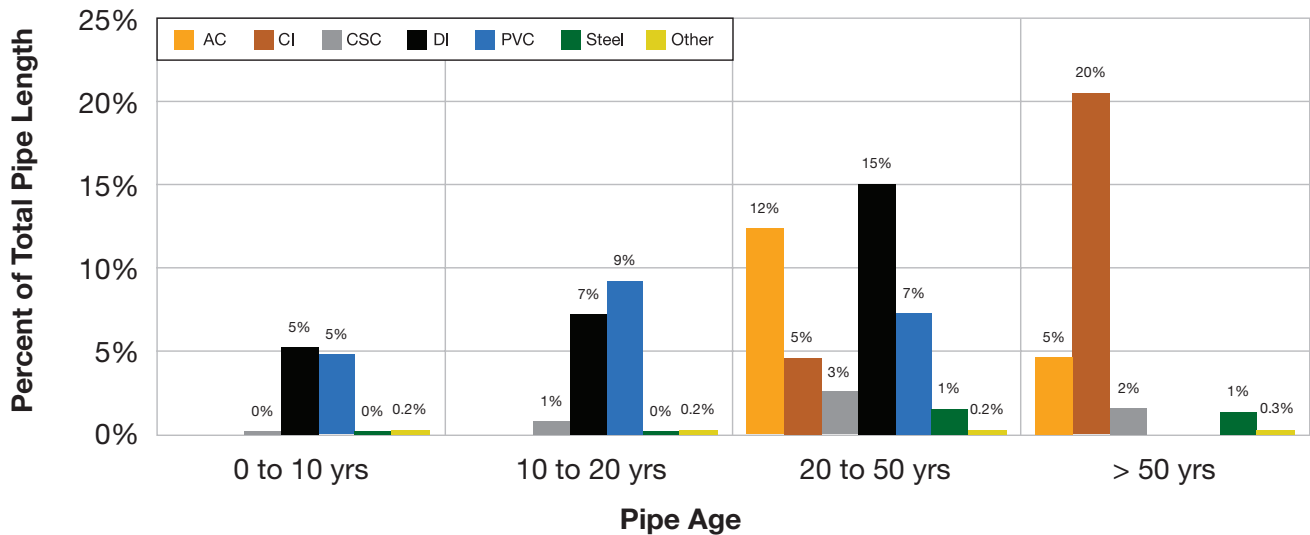
**FIGURE 14: PERCENT OF TOTAL LENGTH OF PIPE BY AGE FROM THE DETAILED SURVEY**

Figure 14 shows the age distribution as a percentage of total length of all pipe materials. For example, cast iron pipe older than 50 years is 20% of all installed pipe. For ages between 0 to 10 years, ductile iron (DI) and PVC both have about 5% of the total installed length. The most common pipe materials installed during the last 10 years are DI and PVC.

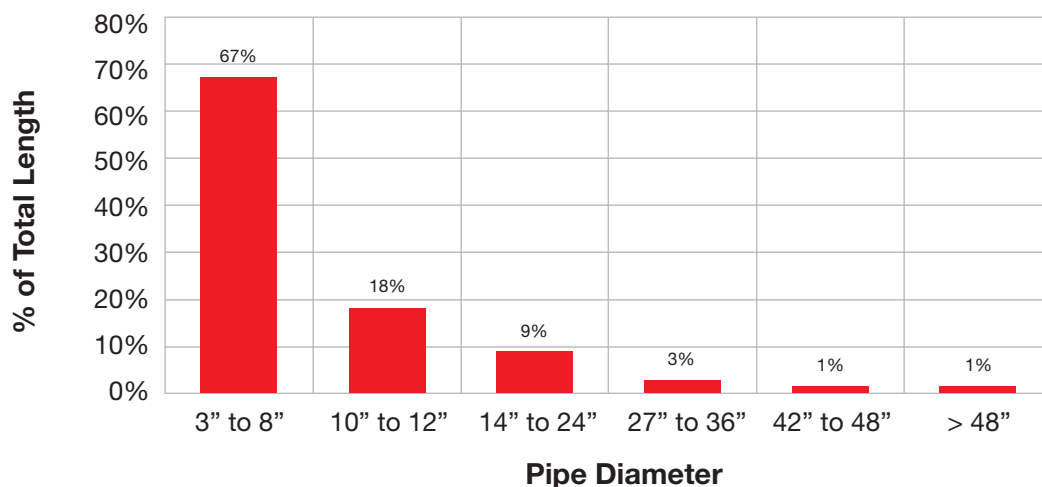
**FIGURE 15: PERCENT OF TOTAL LENGTH OF PIPE BY SIZE FROM THE DETAILED SURVEY**

The detailed survey respondents were also asked to break down the fraction of total installed pipe length by six pipe diameter categories. Figure 15 illustrates the percentage of water main that fit into each size range. Figure 15 indicates that approximately 67% of the installed pipe is 8 inches or less in diameter. The 2012 survey found that 66% of the pipe was 8 inches or less in diameter showing good agreement. Earlier studies assumed 73% of water pipes were 10 inches or less in diameter (Stone et al., 2002). Figure 16 illustrates the diameter distribution for each material type. Figure 16 shows that large diameter transmission pipes are dominated by steel and concrete pipe materials with 18% of all concrete pipe and 14% of all steel pipe having a diameter greater than 48-inches. Figure 17 illustrates the percent of total length of all pipe materials broken down by material type and diameter. Figure 17 illustrates that cast iron pipe from 3 to 8 inches in diameter represents over 19% of the installed pipe.

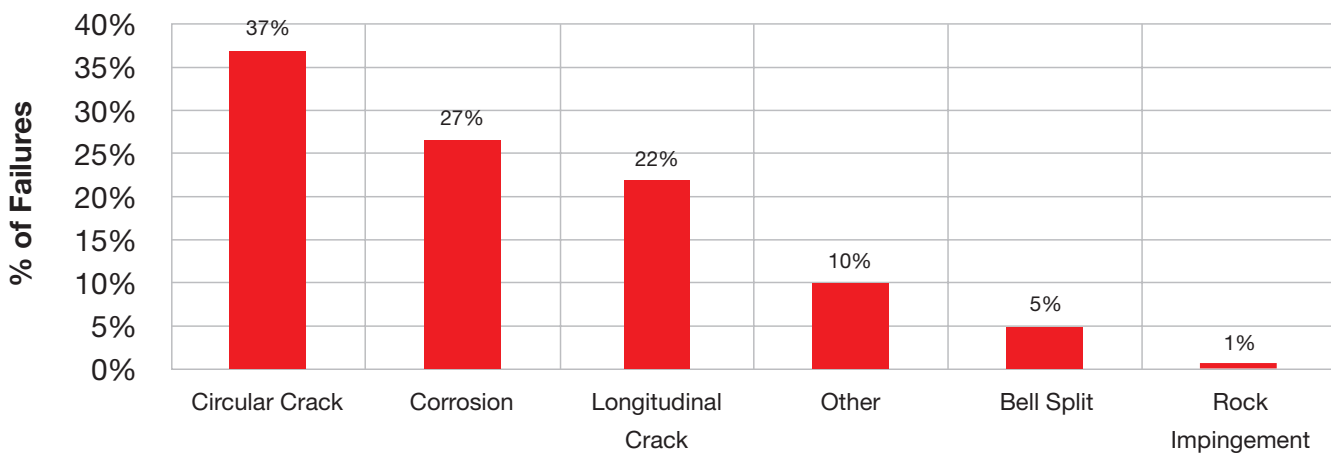
**FIGURE 28: DISTRIBUTION OF FAILURE MODES FROM THE BASIC SURVEY**

An alternate approach to examine the failure modes is by using those reported in the basic survey. Participants were asked to provide a cause of failure from the following list; circumferential crack, longitudinal crack, corrosion (internal or external), bell splitting, rock impingement, other, or unknown. Where multiple failures occurred, multiple causes were given, and each was given equal weight. Figure 28 illustrates the percentage of each failure mode with unknown responses ignored. Again, the top two failure modes are circumferential cracks followed by corrosion.

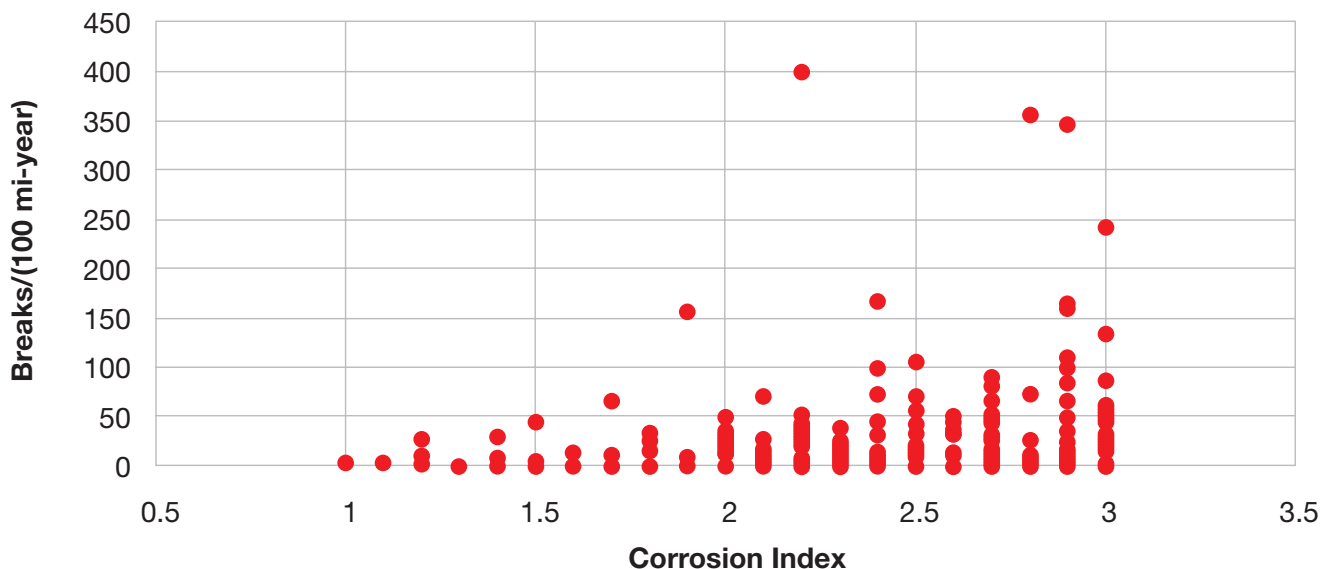
**FIGURE 33: INDIVIDUAL UTILITY BREAK RATES FOR CAST IRON PIPE VERSUS THEIR CORROSION INDEX**

It is reasonable to expect break rates would increase when pipe is installed in corrosive soils. To examine this, plots were made of a utility's corrosion index versus break rate. Figure 33 illustrates this for cast iron pipe. There is a trend of higher break rates with increasing corrosion index, but the wide scatter in the data makes analysis difficult. The high break rates in Figure 33 are associated with small utilities that have a small amount of pipe. Consider a utility with 1 mile of cast iron pipe with 2 breaks during the past year. That would translate to a break rate of 200 breaks/(100 miles)/year. If that utility had no breaks the following year, the break rates drop to zero.

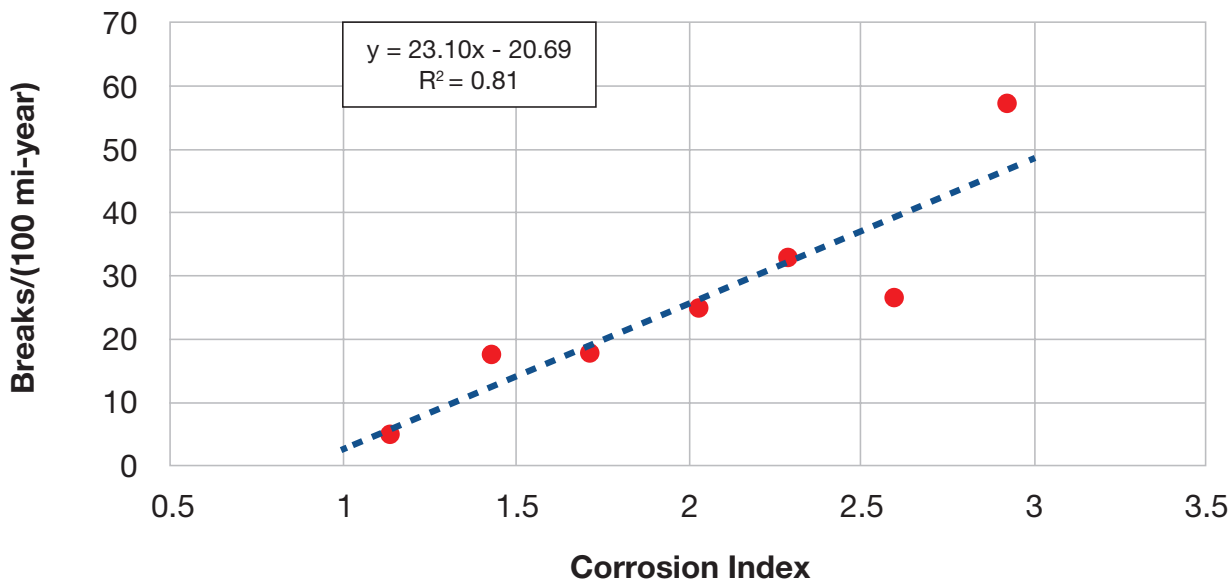
**FIGURE 34: CAST IRON PIPE BREAK RATE VERSUS CORROSION INDEX**

To get a realistic estimate of break rates, we need to add the number of breaks of a pipe type from several utilities and divide by the sum of the length of that pipe type to compute break rates. The corrosion index data was broken down into the same seven categories used in Figure 32. The results are listed in Table 7. The break rates versus corrosion index data are plotted in Figure 34 for cast iron pipe and Figure 35 for ductile iron pipe. The figures also contain a regression equation fit and a correlation coefficient. Correlation coefficients close to 1.0 indicates an excellent correlation and zero indicate no correlation. Both cast and ductile iron results in reasonably good fits to the data.

Using the equations in Figure 34 with  $x=1$  for a low corrosion risk and  $x=3$  for a high corrosion risk, one can show that a cast iron pipe in a high corrosion soil is expected to have over 20 times the break rate of one in a low corrosion soil. Similarly, ductile iron pipe in a high corrosion soil has over 10 times the break rate than one in a low corrosion soil. Very poor correlations were found for the other material types in this survey.

Analyses of soil corrosivity completed in this study shows that a cast iron (CI) pipe in highly corrosive soil is expected to have over 20 times the break rate of a CI pipe in low corrosive soil. Traditionally, the thickness of the iron pipe wall provided the additional corrosion protection. CI pipes manufactured after World War II have significantly higher failure rates due to thinner walls. The resulting higher main
